ELAN Rev B3 Errata / Anomalies / Design Changes**Revised 07/17/95**

Errata numbers preceded with "E" are carried over from the ELAN Rev. A, those preceded with "EB" are new to the Rev B3.

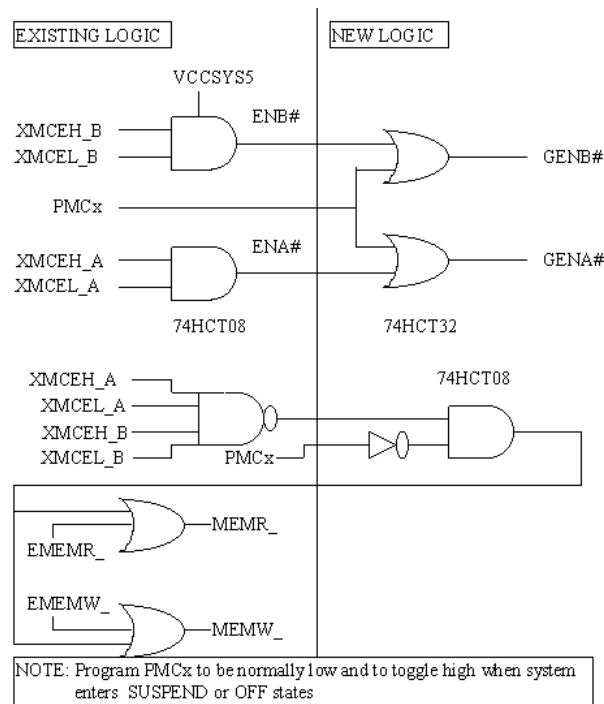
#EB 26**PCMCIA Card Enables during SMI/NMI handlers in SUSPEND mode****REVISIONS
EFFECTED:**

During a temporary-on SMI/NMI handler when the PMU is in the SUSPEND or OFF PMU state, the PCMCIA Card Enables: (XMCEL_A, XMCEH_A, XMCEL_B, and XMCEH_B) are driven to '0's. This will cause the PCMCIA cards to drive data onto the SD bus during read cycles.

The PCMCIA Card Enables will be driven low during temporary-on SMI/NMI handlers when the PMU is in SUSPEND or OFF mode. Unless the PCMCIA sockets' data drivers are disabled, this will cause data contention on the SD bus between the two PCMCIA sockets and any other decoded device during an ISA bus read. In addition, all write cycles that go to the ISA bus will cause data to be written into both PCMCIA sockets.

If the user desires to use temporary-on SMI/NMI handlers during SUSPEND or OFF mode AND the PCMCIA sockets will drive data onto the SD bus (i.e. their data bus drivers have not been powered off or disabled), the following H/W solution may be implemented:

Gate the PCMCIA Card Enables with a PMC line that is programmed to indicate that the PMU state SUSPEND has been reached. PMC Suspend state control functions are in registers 81h, ABh, and ACh. The gating function should disable the ELAN's PCMCIA Card Enables from causing the sockets to drive data onto the SD bus. In addition gate the inverted PMC line (programmed for SUSPEND) with the existing MEMR /MEMW lines which currently are gated off when any XMCEx line is asserted. The new logic will keep MEMR/MEMW asserted while in a temp SMI/NMI handler during SUSPEND or OFF mode. See pictorial below.

Note: this fix will disable PCMCIA accesses in SUSPEND and OFF modes.

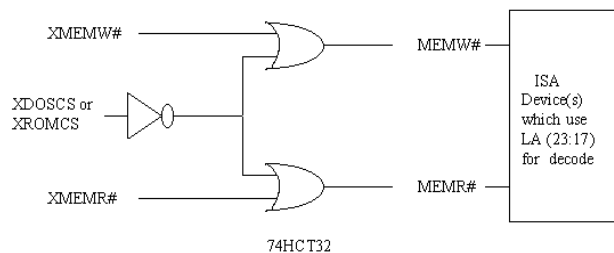
#EB 27**ISA Bus Conflicts during Fast ROM accesses**

When the ELAN Rev. B is configured in the FULLISA pin-mode and ROM accesses are configured to run at the Fast CPU clock rate, the BALE (LVDD pin) output will not be asserted for FAST ROM accesses. If the last ISA cycle that asserted BALE is decoded by an ISA device that uses LA(23:17) in its decode, that device will conflict with FAST ROM accesses until BALE is reasserted.

ISA bus conflicts will be seen during FAST ROM cycles after an ISA device that uses LA(23:17) has been accessed.

Externally 'OR' the ISA memory commands (XMEMR and XMEMW) with the inverted version of the ROM chip select(s) (XROMCS and/or XDOSCS) that are enabled to run at the Fast CPU clock rate. The outputs of the 'OR' gates would then be routed to all ISA devices that use LA(23:17) to decode accesses. In addition, the XROMCS and XDOSCS outputs that will be used for FAST ROM accesses should be configured as address decodes and not internally qualified with the memory commands. This is programmable via Index B3H bit 2 (XROMCS) and Index B8H bit 4 (XDOSCS). See pictorial below.

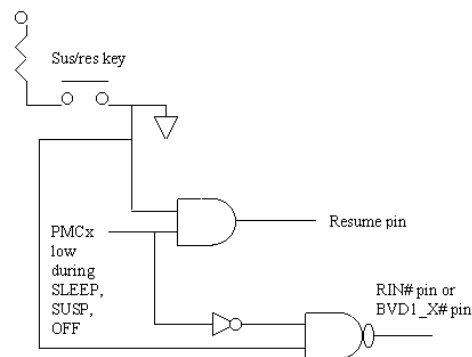
#EB37**RESUME Event May Cause System Hang**

If the PMU receives a temporary-on event while the Low Speed PLL (LSPLL) is shut down and the PMU is in SLEEP, SUSPEND, or OFF mode, and a RESUME key press is received during the 256ms PLL startup interval (as defined by Index 8FH bits 2-0), the RESUME event will force the PLL startup timer to be reset causing the internal clocks to remain shut off. Since the internal clocks remain gated off, the system will hang. When this condition occurs, the system may be restarted by forcing XBL4 or XBL2 low while ACIN is low and the appropriate bit is set in Index 74H bits 6 or 7.

RESUME events generated by the SUS/RES key may cause system hangs when temporary-on SMI/NMIs are enabled in SLEEP, SUSPEND, or OFF modes.

Gate Off the SUS/RES switch signal from the Resume pin on the ELAN using a PMC or PGP signal, such that the RESUME function is disabled while the PMU is in SLEEP, SUSPEND, or OFF modes. Also Gate the SUS/RES switch signal to an unused wake-up pin, such as RIN#, BVD1_X#, etc, to effectively act as the Resume signal to wake-up the system.

Since gating off the SUS/RES pin eliminates the ability to generate a Resume SMI, the following SW implementation is suggested if this functionality is necessary. Enable a DOZE to SLEEP transition SMI /NMI (will catch SUSPEND action of SUS/RES switch, BL2 and BL4). Once in the SMI routine, read the NMI/SMI control reg A5h, if bit 2 is set (DOZE to SLEEP transition) power down appropriate devices, write 0 to reg A5h (allow transition to SLEEP), then jump into a SW loop polling on PMU mode/and or Status bits (polling will halt once SLEEP mode is reached and the CPUCLK is halted). When an activity, wake-up, SUS/RES key press (via RIN or BVD1_X), or Temp on event (BL1, BL3, or PMU state transition) is received, the loop will resume, powered down devices can be re-enabled and the SMI/NMI handler exited when the polling loop detects FULL-ON mode. If the event warrants staying in a clock OFF mode - SLEEP, or transitioning to a lower PMU mode (SUSPEND or OFF) than clear NMI/SMI via reg A2H write, do appropriate tasks and remain in the SW loop. See pictorial below:

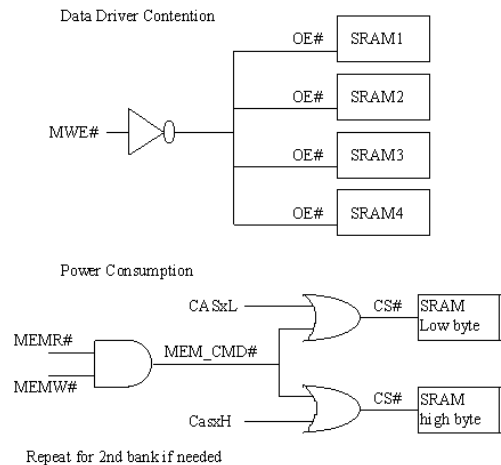
#EB 40**Refreshes not disabled when using SRAM I/F**

When the ELAN is configured to use SRAM for main memory (bit 0 of Index 70h is set), the CAS signals are asserted when the internal refresh signal is generated. For this SRAM configuration, the CAS signals are used for the SRAM Chip Select signals. Assertion of the CAS signals may cause the following problems:

Data driver contention on the D(15:0) signals when the ELAN system is configured to use two banks of SRAM for main memory. Also, additional system power consumption will be observed since the SRAM's Chip Selects will be periodically asserted.

To eliminate system power consumption created by refreshes, the following should be implemented:

Clear bit 2 of Index 48h to enable the MEMR# and MEMW# commands to be asserted during SRAM accesses. AND the MEMR# and MEMW# signals to generate an active low MEM_CMND signal. For each byte of SRAM used, OR the associated CAS signal with this MEM_CMND signal prior to connecting it to the CS pin of an SRAM. If this solution is implemented, the system designer should also qualify the Memory Command signals sent to any ISA device that does not fully decode the ISA address signals. See pictorial below:
